# The Sustainability of Water Supply Schemes

*A case study in Alaba Special woreda*

March 2008

**Working  
Paper 5**

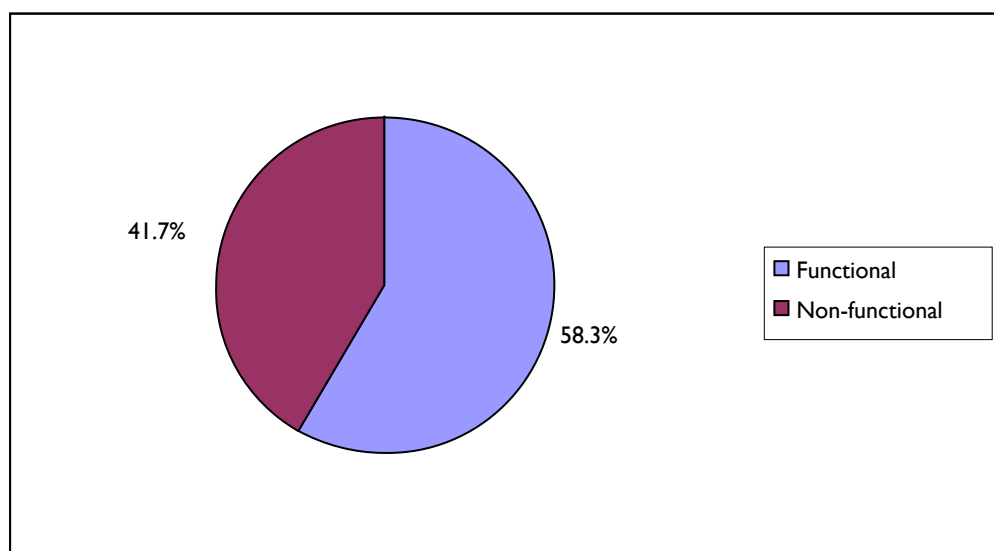
Figure 3.2: Proportion of functional and non-functional schemes

In the Woreda, there is a high rate of scheme and water point breakdown. During the survey, 42% (Figure 3.2) of the schemes and 62% of the water points were found to be non-functional (Table 3.1). Pump failure, generator problems and pump head problems accounted for 70%, 10% and 20% of scheme breakdowns, respectively.

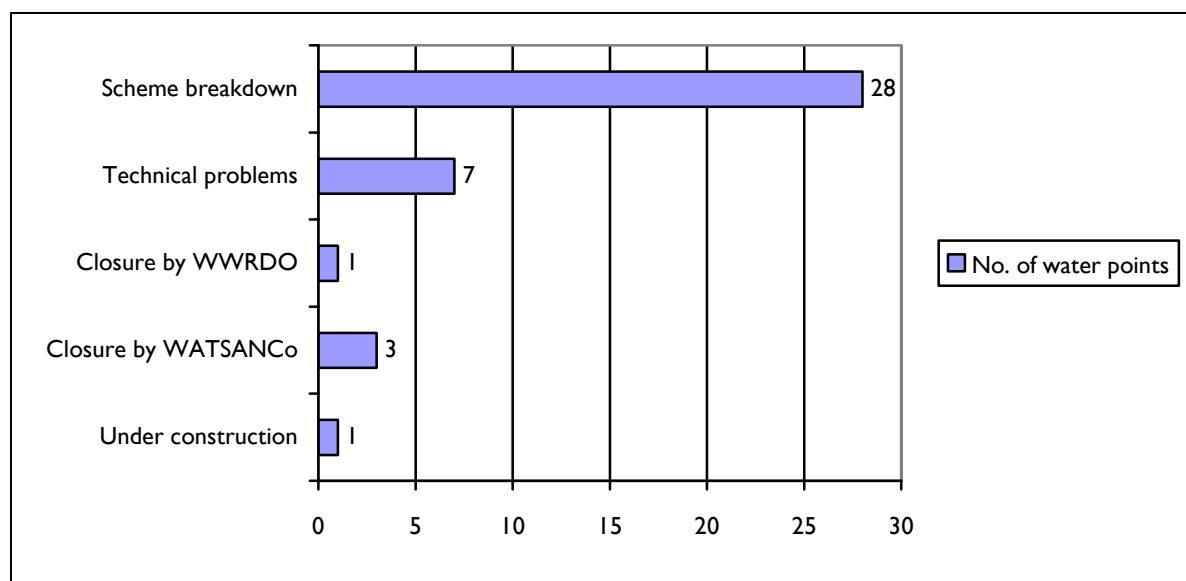
Figure 3.3: Major reasons for the non-functionality of water points

Out of a total of 65 water points, 62% are not providing a service to the community. The major reasons for the non-functionality of water points include (Figure 3.3): scheme breakdown (70%), technical problems (18%), closure by the WWRDO owing to WATSANCo management problems (3%) and closure by the WATSANCo to save the money paid to tap attendants (8%). A total of 3% were still under construction.

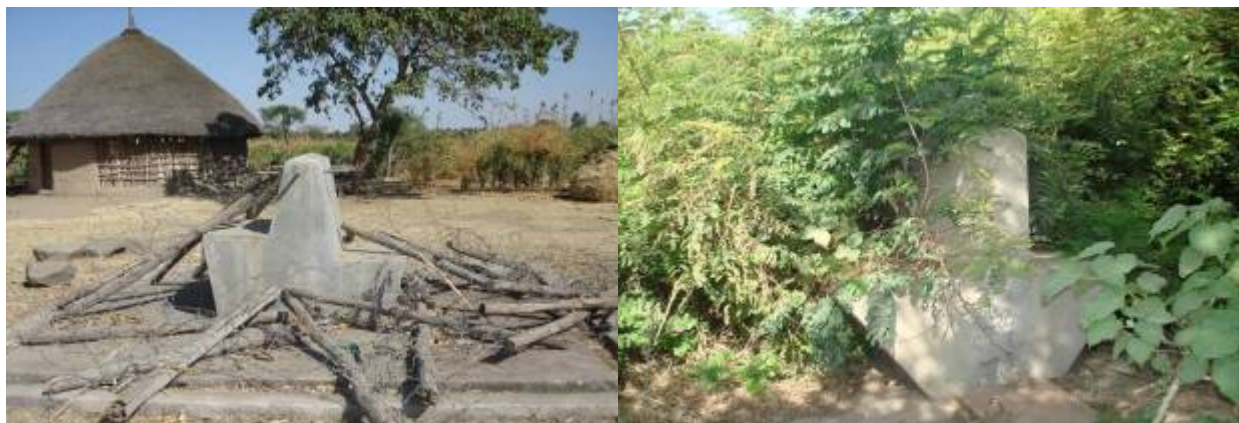
Figure 3.4: Non-functional water points at Lower Lenda and Ashoca

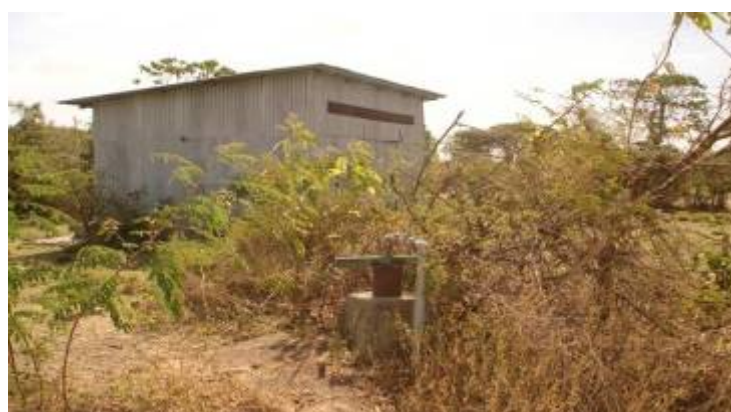
Figure 3.5: Non-functional scheme, Bendo

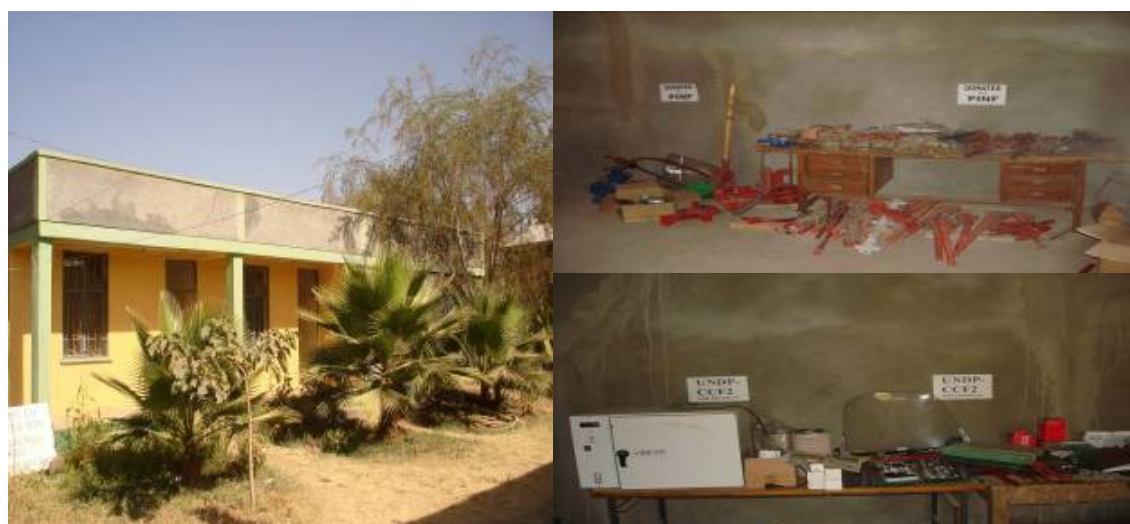
The WWRDO has one building with two offices and one workshop. The building was constructed in 2004 with the financial support of the United Nations Development Program (UNDP). The WWRDO has only three functional motorbikes, with the furthest scheme (Yato Behreo) about 105km far from Alaba town. In the workshop, different spare parts and hand tool kits, donated by UNDP and PINF (Figure 3.10), important for minor maintenance, were seen. The WWRDO does not have the human, finance and logistical resources to undertake major maintenance (Table 3.6).

Figure 3.10: WWRDO and spare parts and hand tools donated by PINF and UNDP

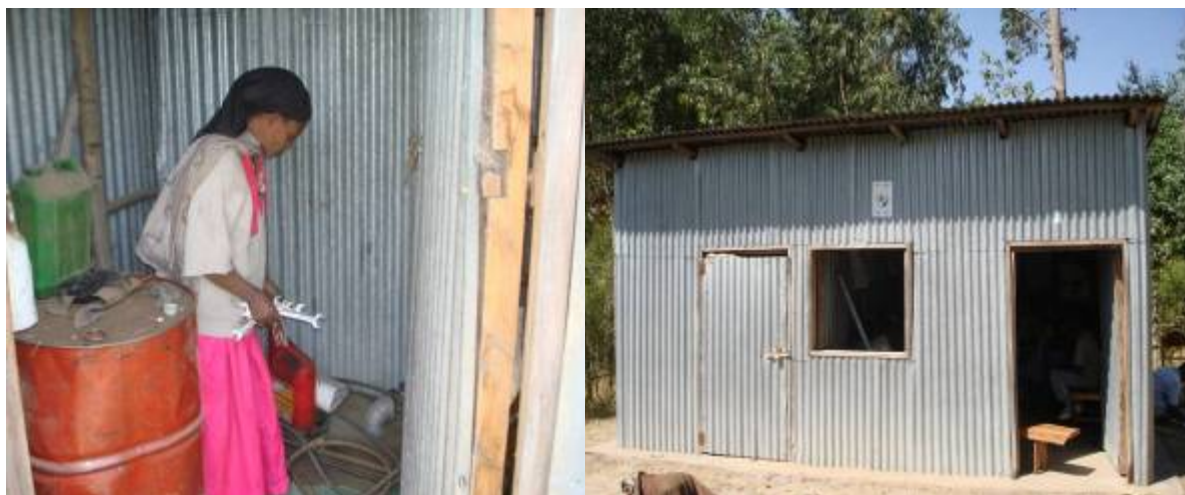
The field investigation discovered that only schemes constructed by Water Action (Choroqo and Ashoca) had a well furnished WATSANCo office and important hand tools for minor maintenance. No other schemes have an office, except Debeso, where the power house has also been serving as an office, or important hand tools to undertake minor maintenance, except Debeso and Upper Tuka, each with one 24" pipe wrench, and Lower Arsho, with two cutters and one pipe trader (Table 3.4).

Figure 4.2: Hand tool store and WATSANCo office at Ashoca and Choroqo

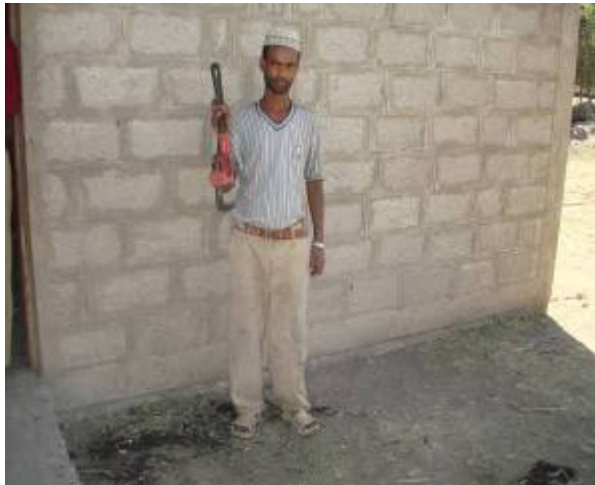
Figure 4.3: Operator of Upper Tuka with the only maintenance tool, a pipe wrench

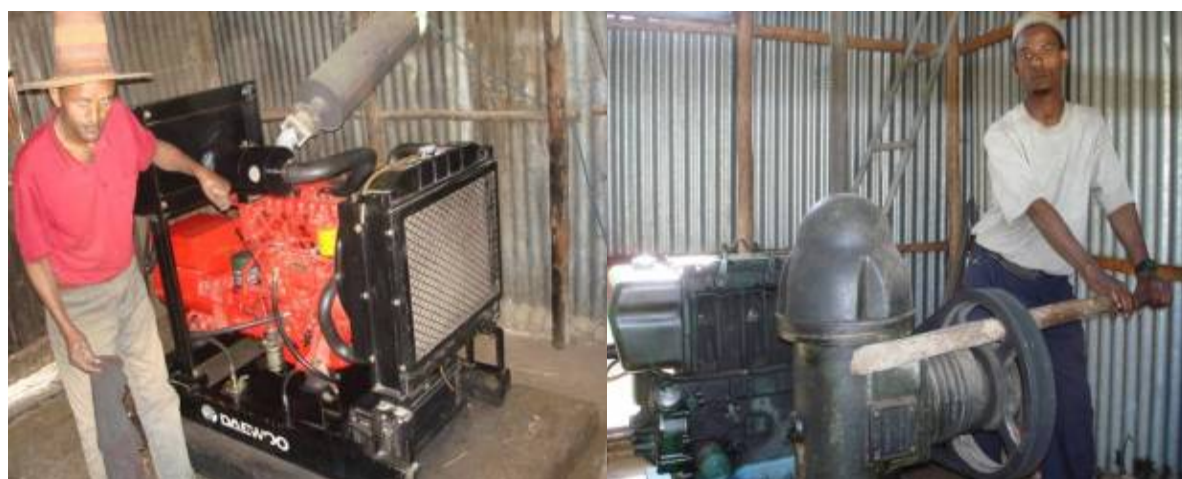
Environmental factors mean that it is difficult to provide a choice of different scheme technologies, like hand pumps, shallow wells, etc. However, it is still possible to have technology that is effective and able to provide an efficient service to the community. In the Woreda, except for design and construction problems, submersible pumps were found to be more effective than mono-lift pumps. Generally, for the sake of spare parts provision and maintenance, it is good to have a standard for the pumps and generators in the Woreda.

Figure 4.9: Generators of submersible (First Meqala) and mono (Choroqo) pumps
